نتایج بررسی سانحه تصادم کشتی تانکر سانچی با کشتی فله بر کریستال

سازمان بنادر و دریانوردی - اردیبهشت ۱۳۹۷

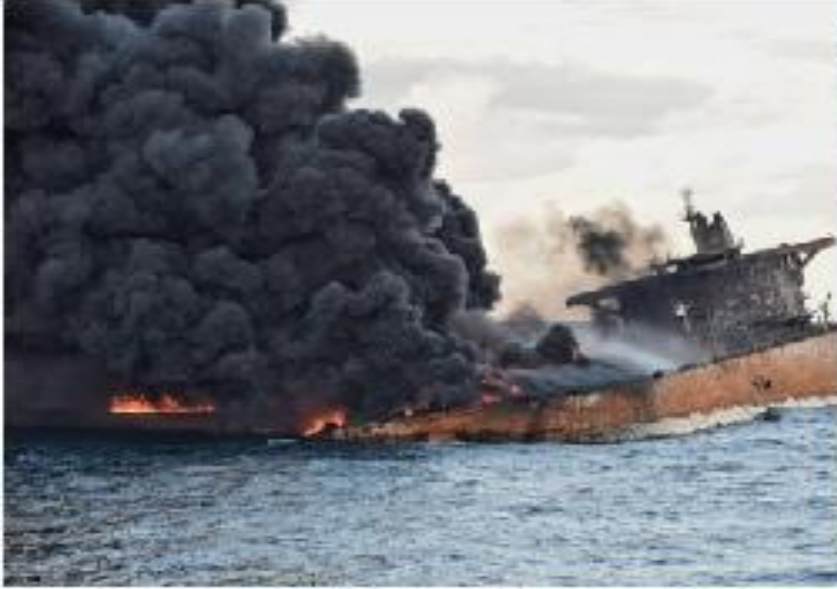
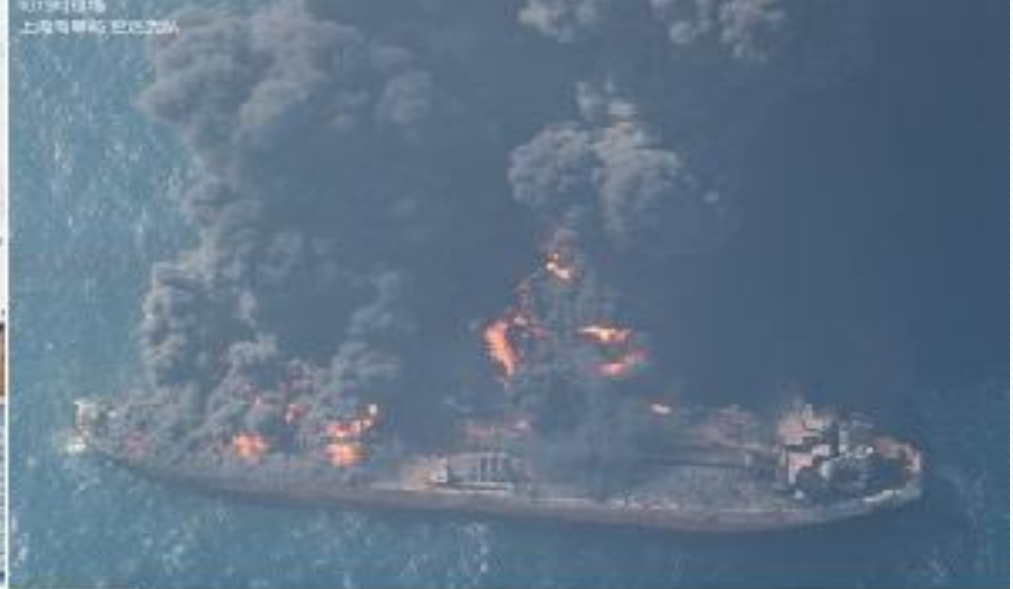
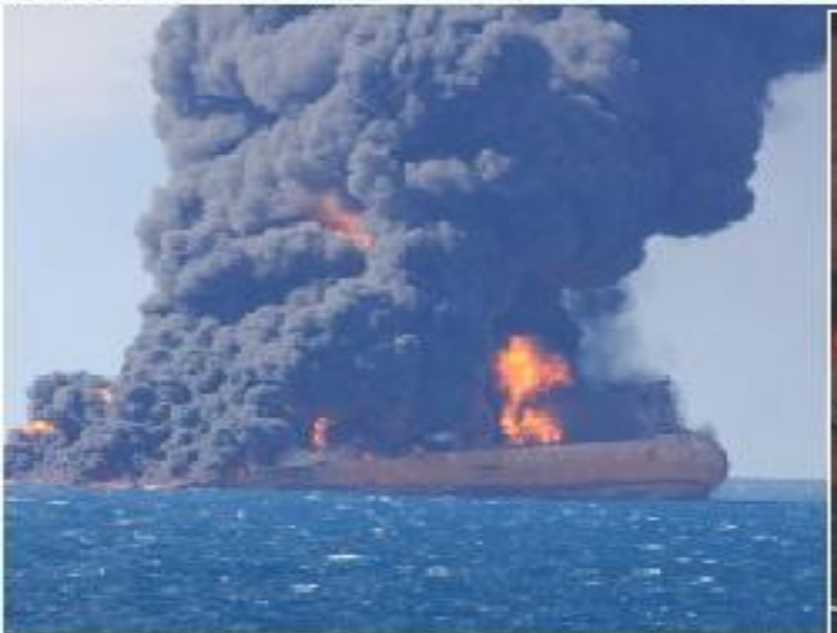
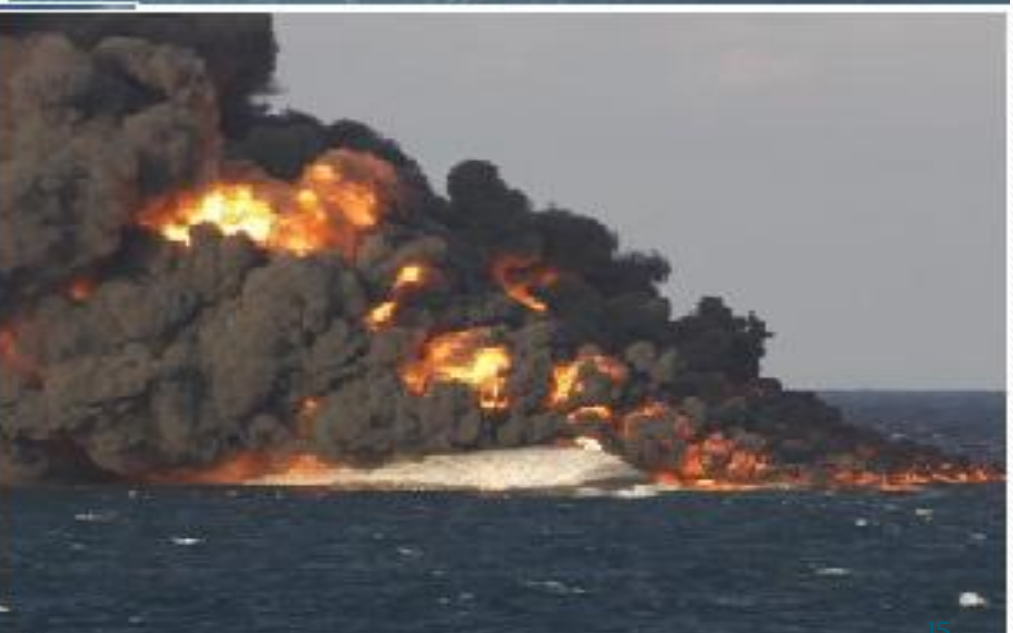
خسارات وارده به کشتی تانکر سانچی

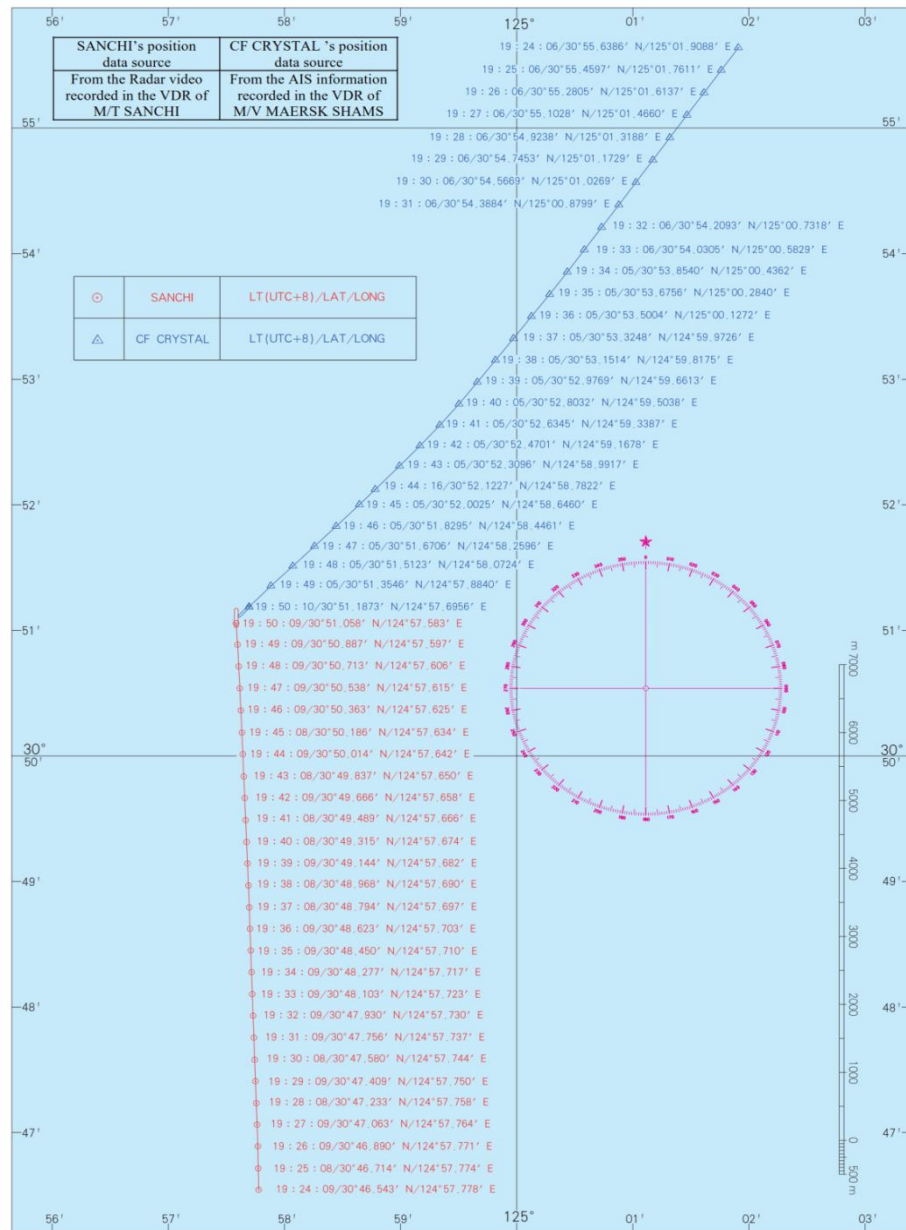
تحليل مسير بر خورد کشتی فله بر کریستال با تانکر سانچی

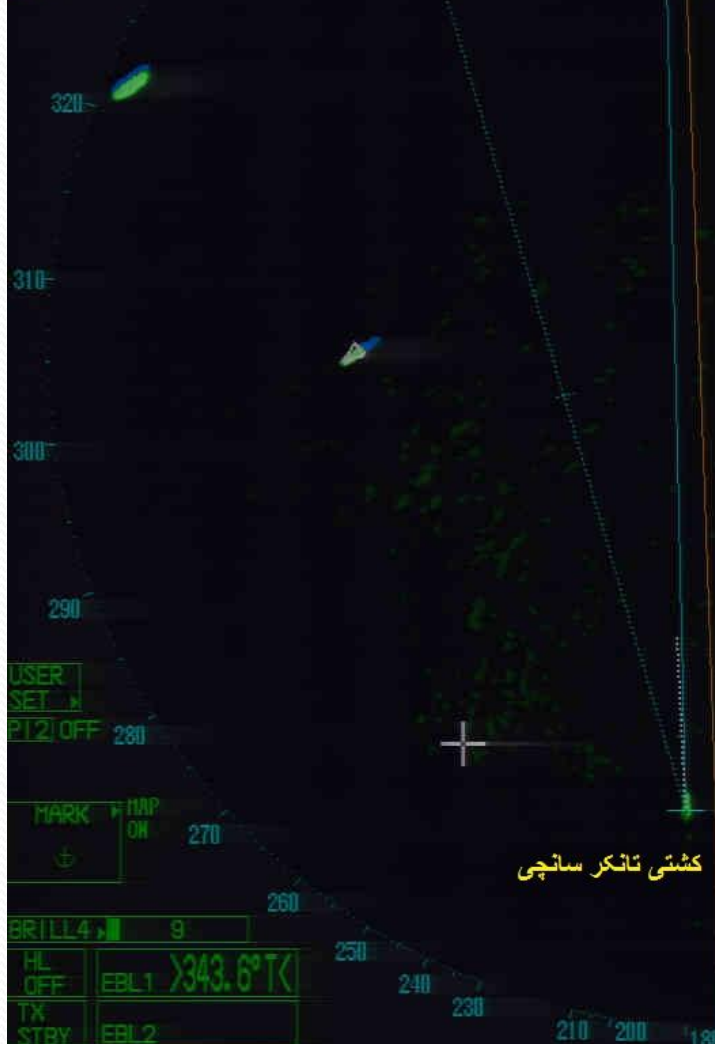
- **Several vessels and boats crossing from starboard bow on Sanchi radar . CF Crystal first appears on radar screen (distance \approx 9.8 nm Speed=13.2 Co=214).**
- **Sanchi Speed: 10.4 knots**
- **Range scale RADAR in use 6 NM off center relative motion.**

کشتی فله بر کریستال

کشتی ماهیگیری

کشتی تانکر سانچی

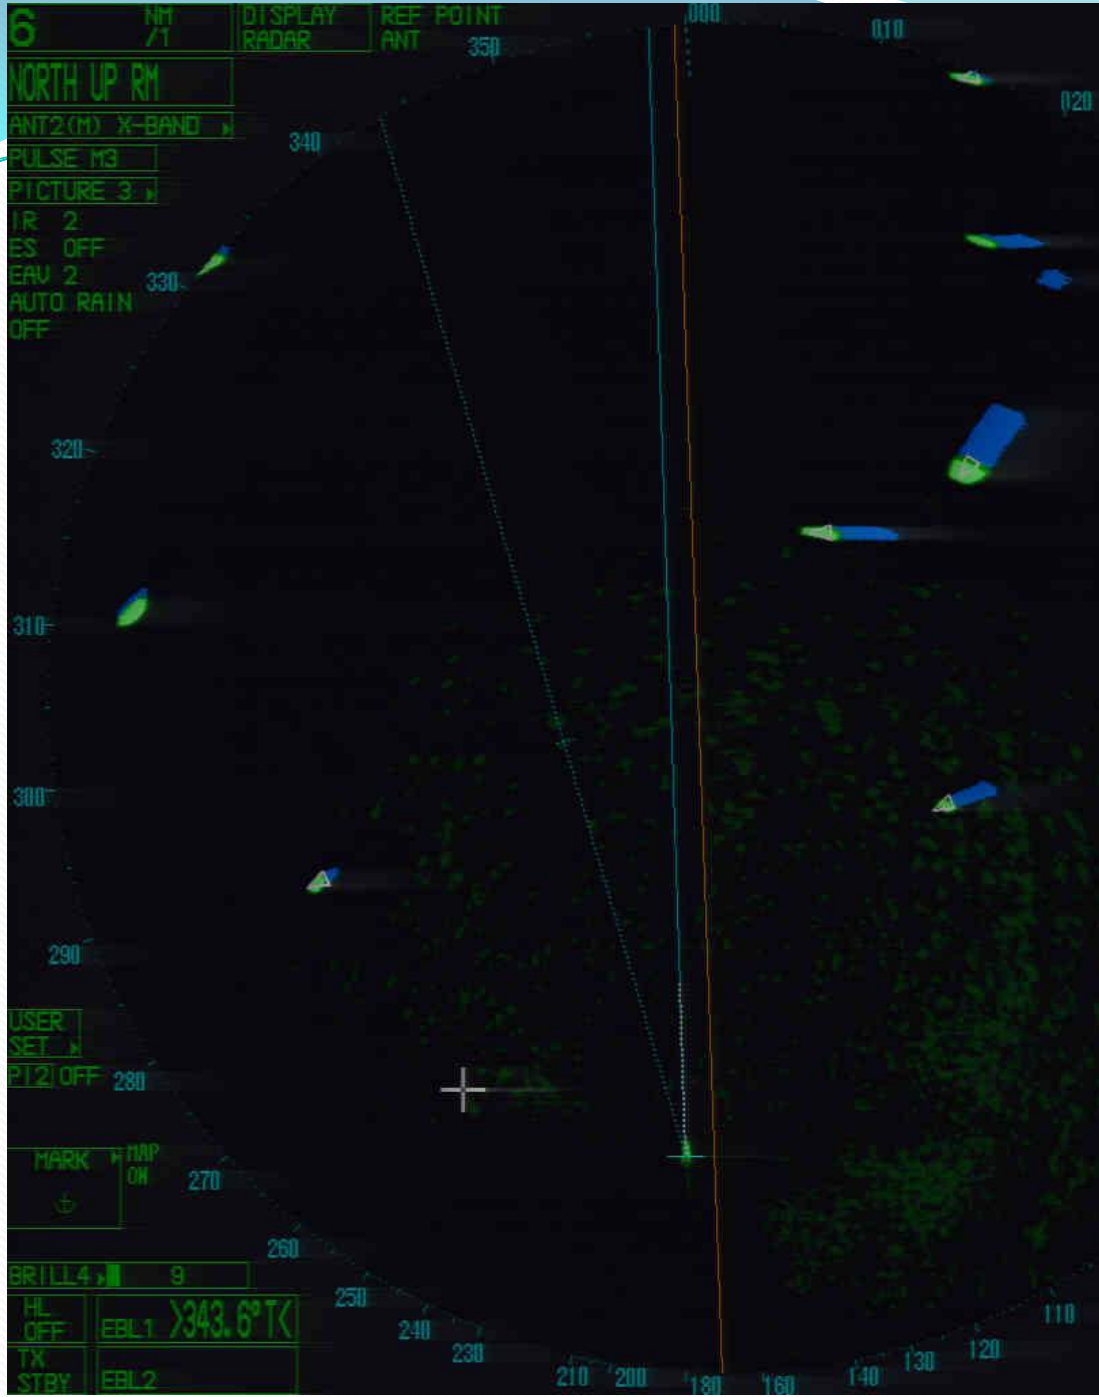
- Sanchi duty officer again start assessing the situation , Said:
- From Sanchi BCR (Bow Crossing Range) (of target A and B)are minus.
- 3/o talked about 3 targets .
- The bearing/range of CF Crystal was 022°/6.8nm from VDR radar data.
- Crystal Chief officer found 2 AIS targets CPA on radar 0.9 and 0.4, [first interview on 25 Jan 2018]
- he confirmed that 0.9 NM was MT Sanchi passing my bow[2nd interview on 2 Mar 2018].

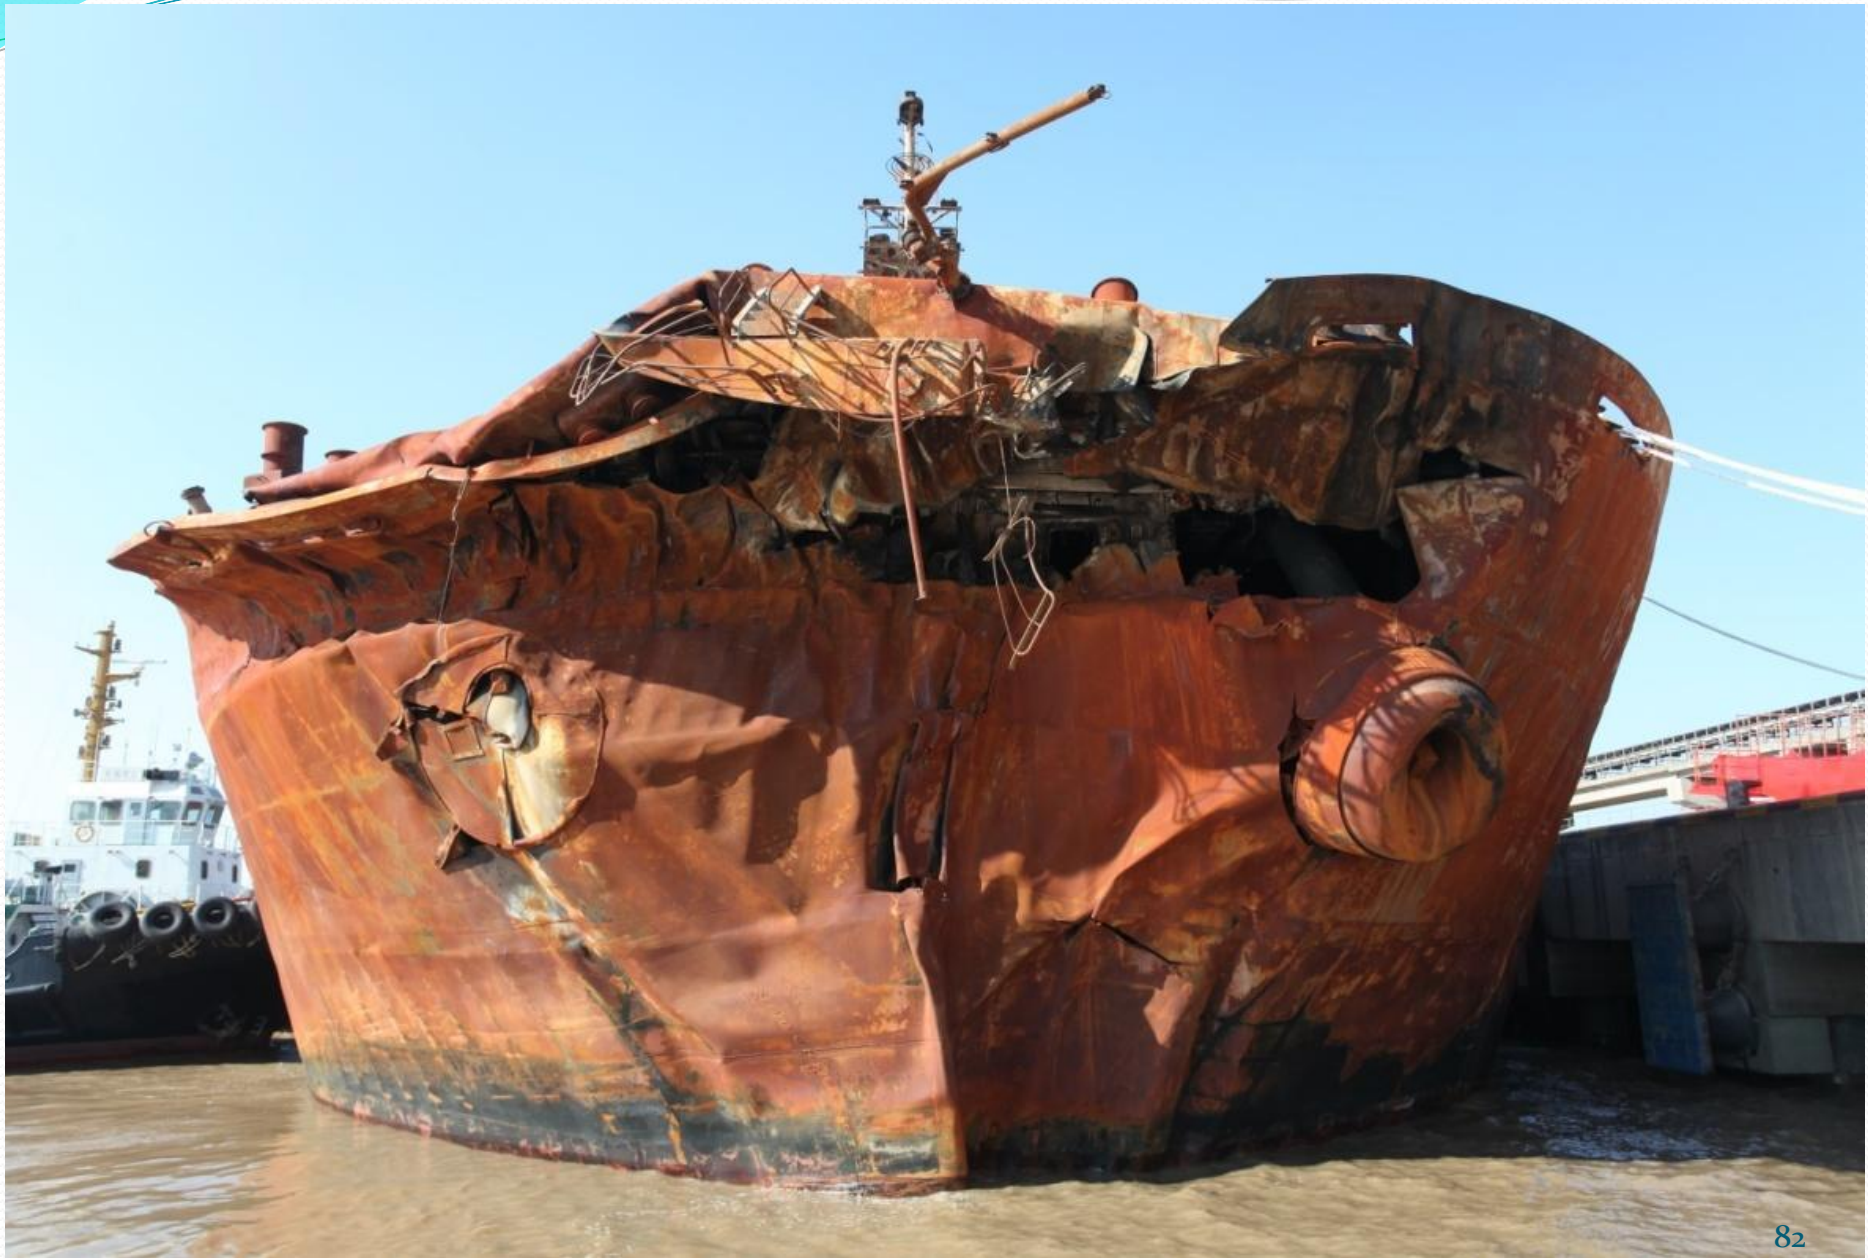
خسارات وارده به کشتی فلّه بر کریستال

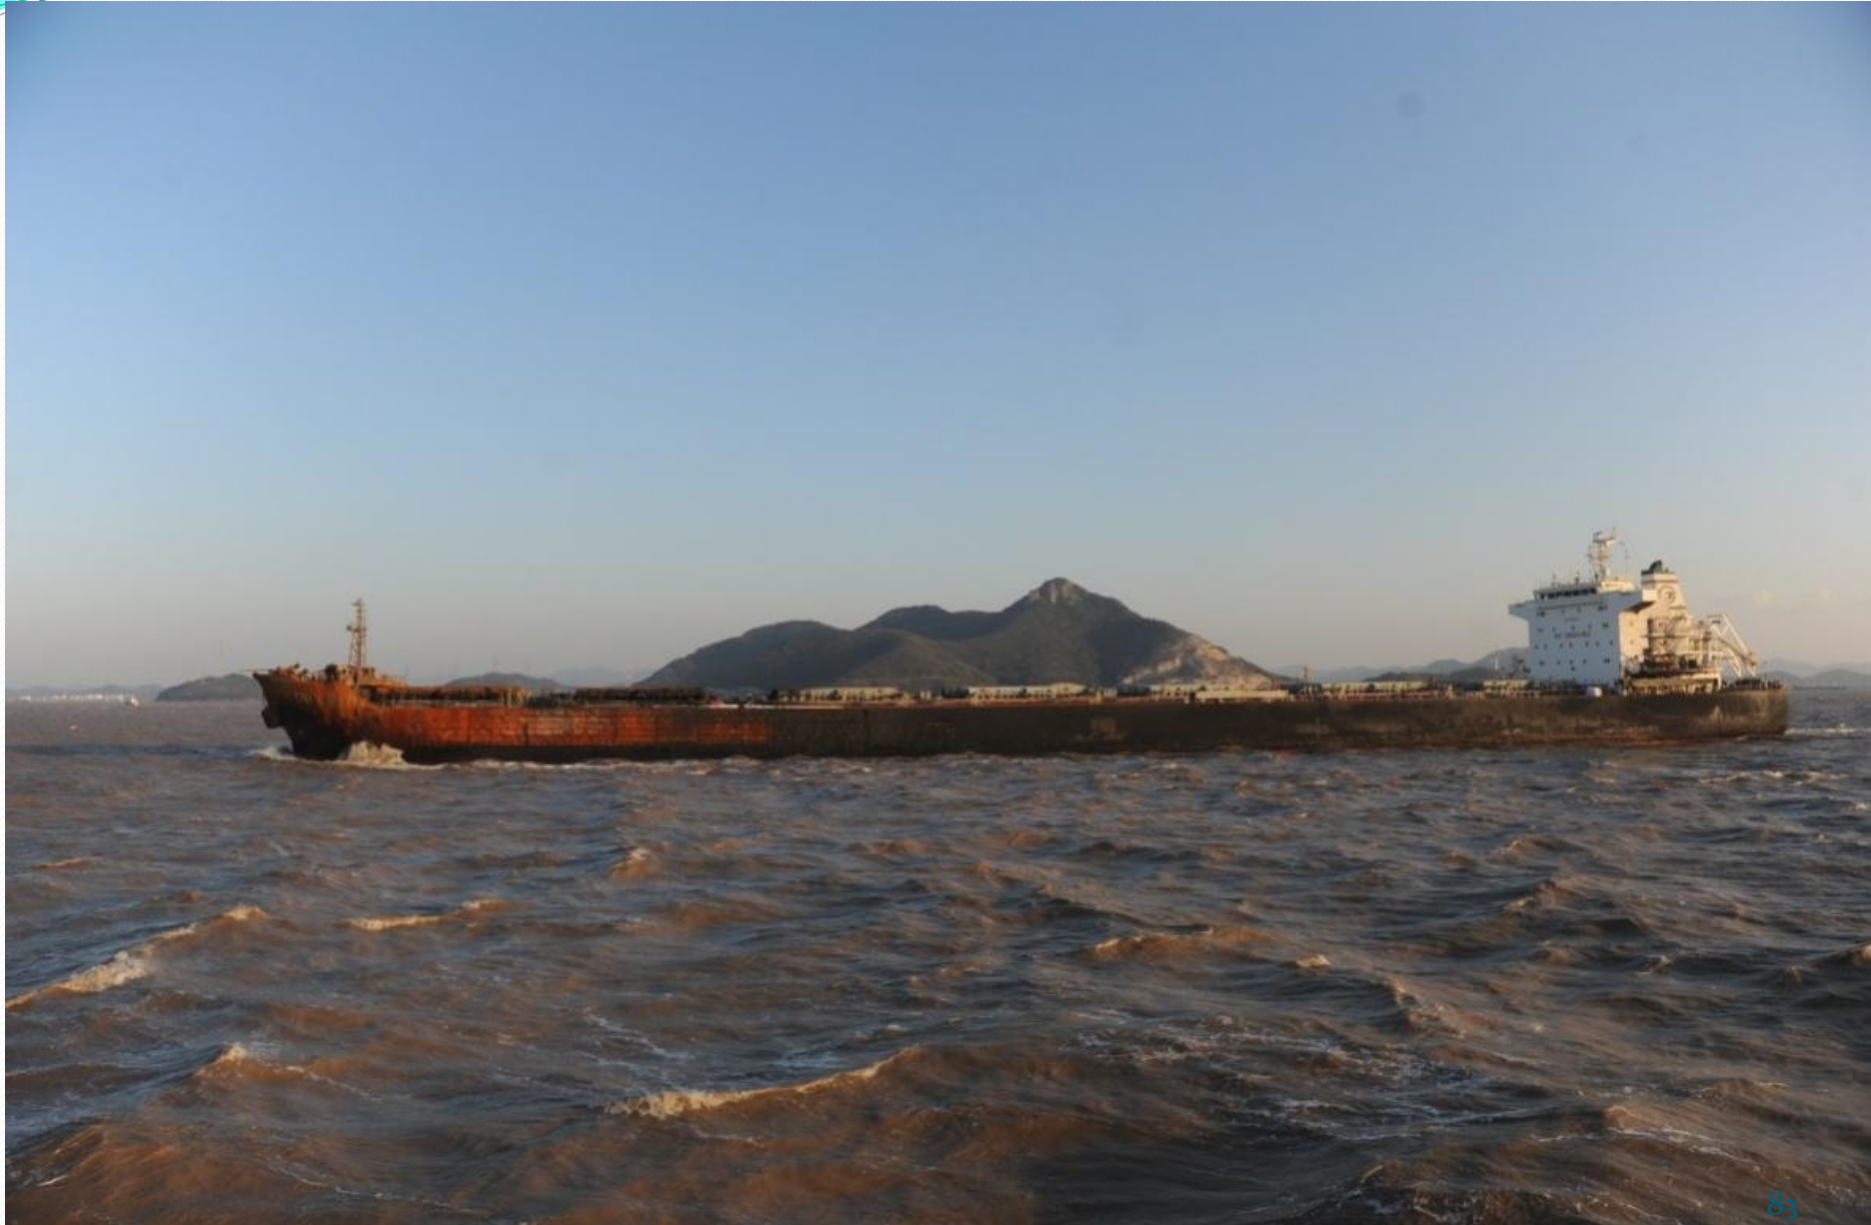
سوختگی کامل سمت چپ کشتی فله بر کریستال

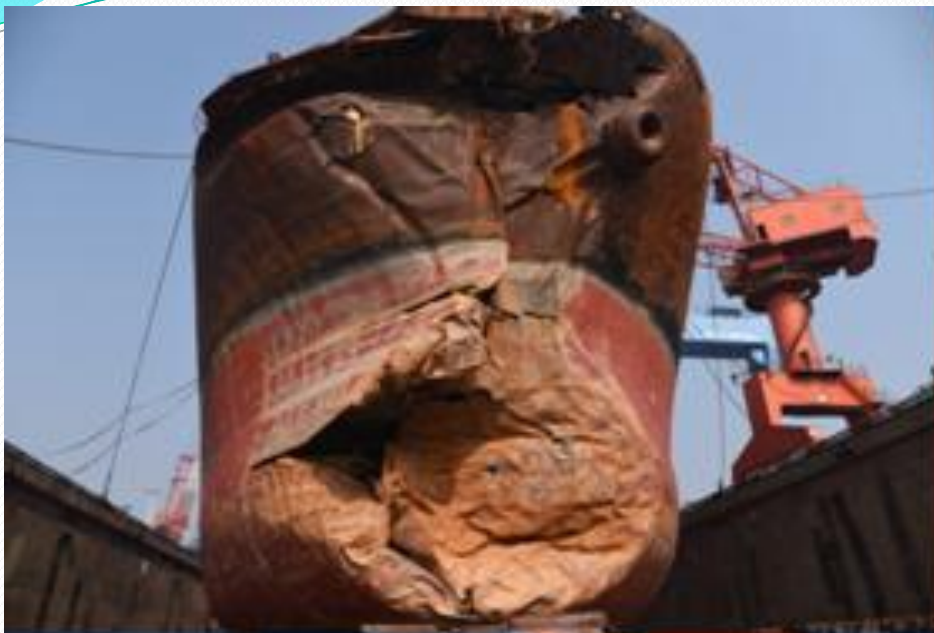
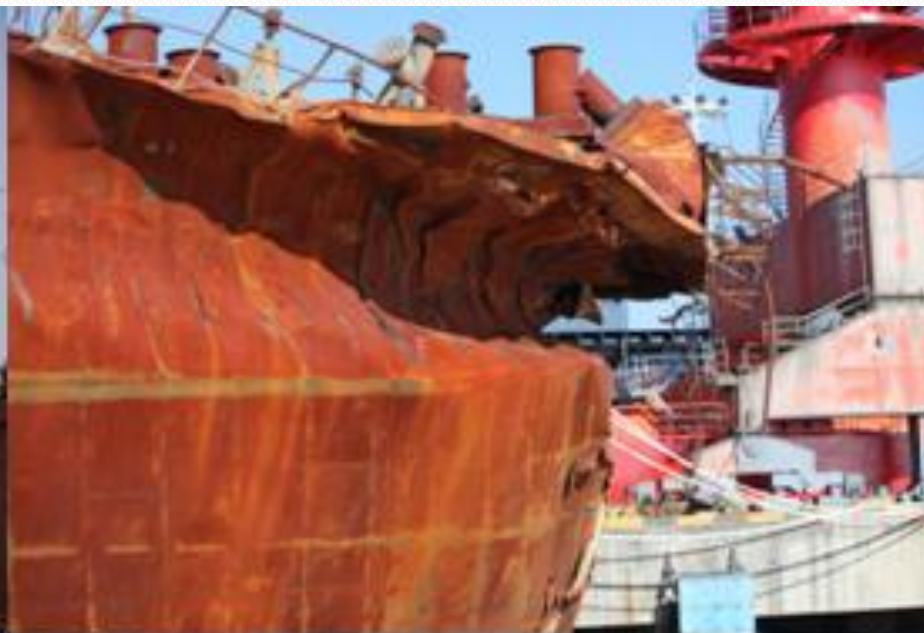
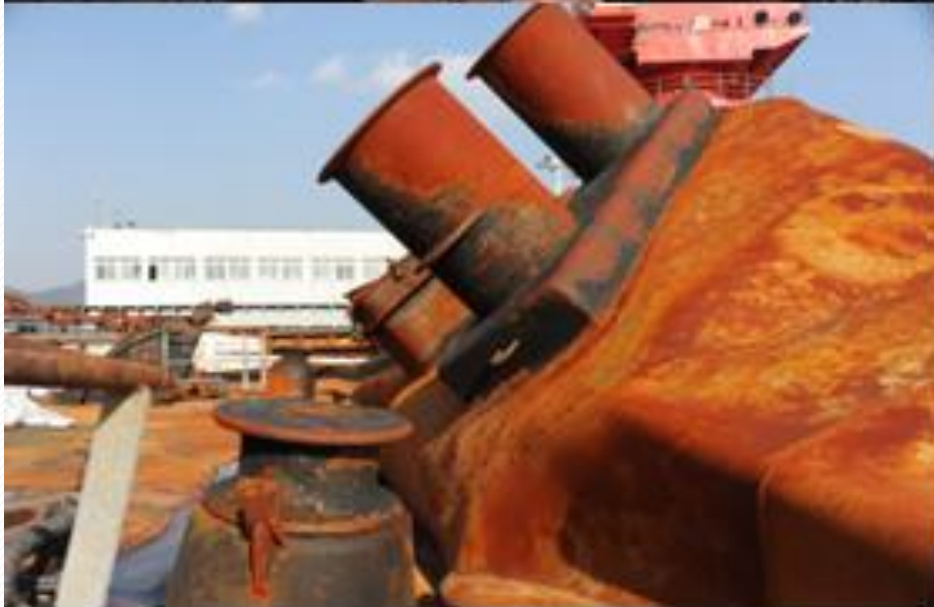
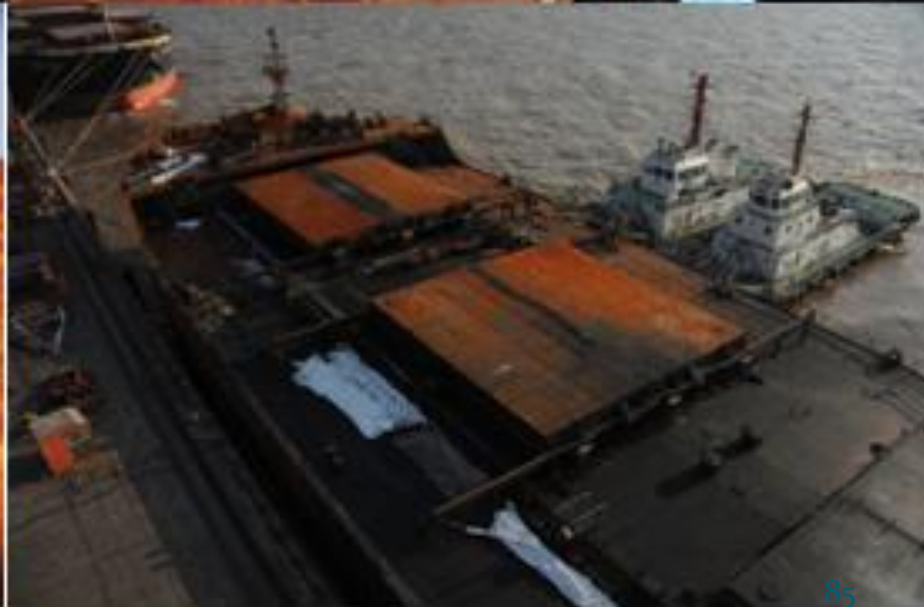
سوختگی تا انبار سوم و خسارت دماغه کشتی فله بر کریستال

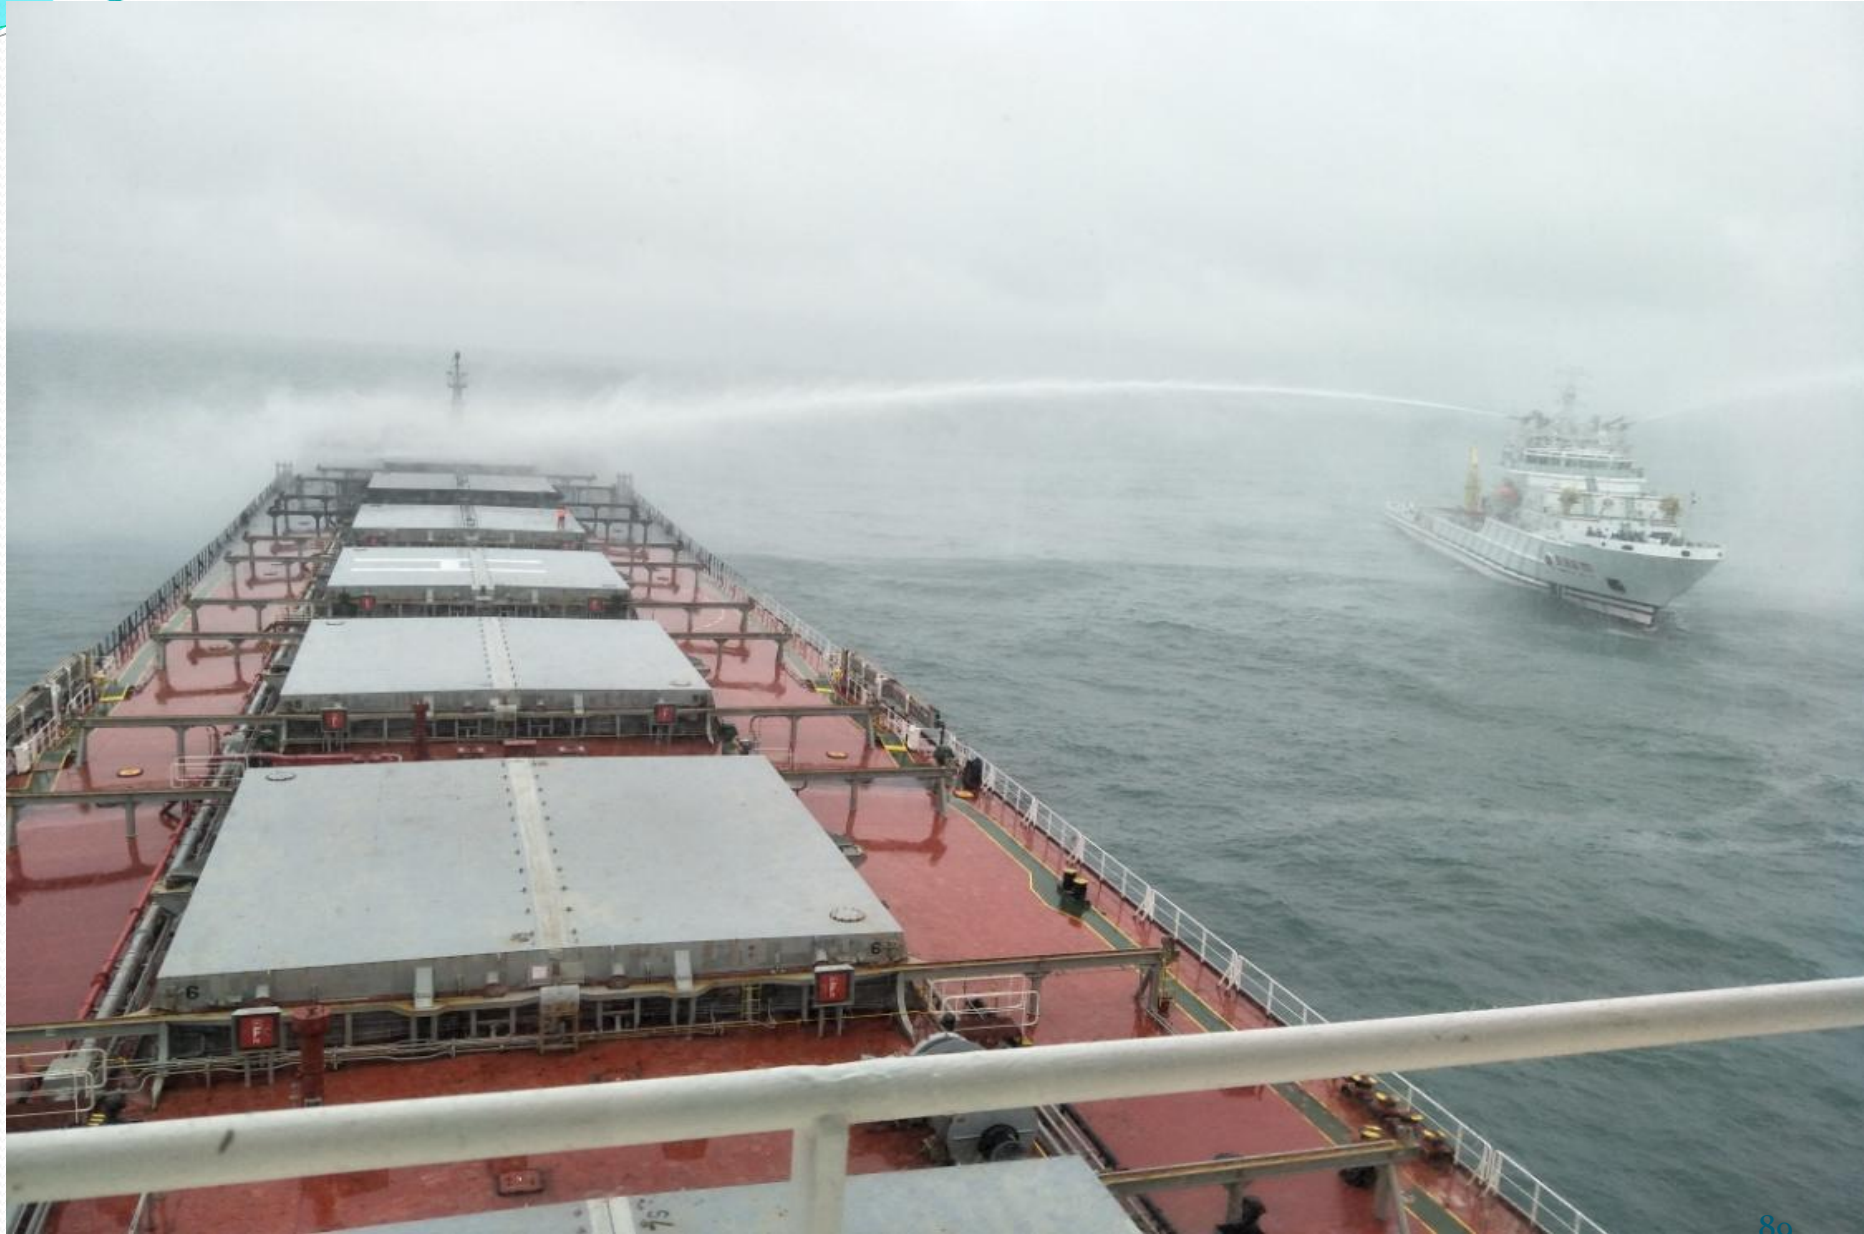
اطفاء حریق کشتی فله بر کریستال توسط گروه نجات

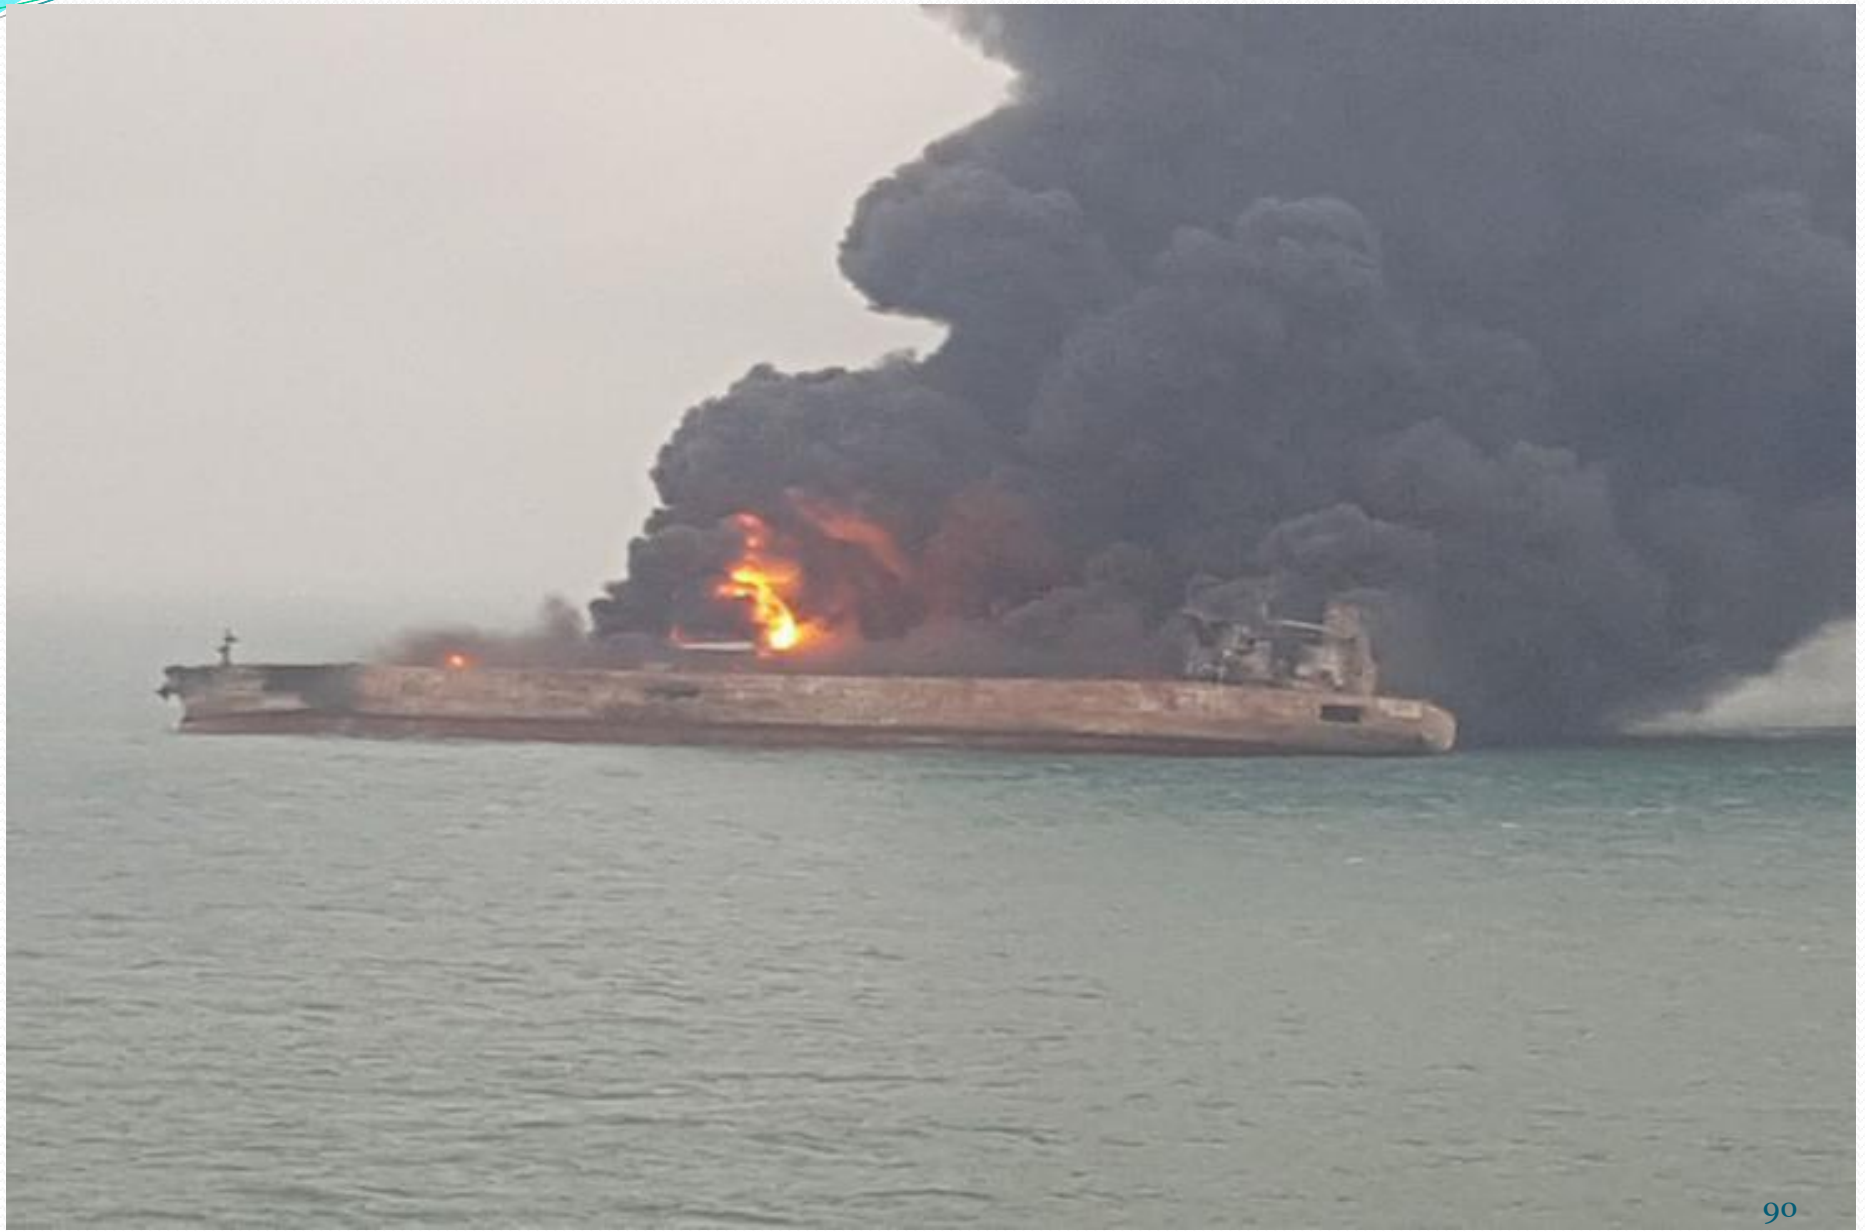
توسعه دود و گازهای سمی ناشی از حریق محموله سانچی

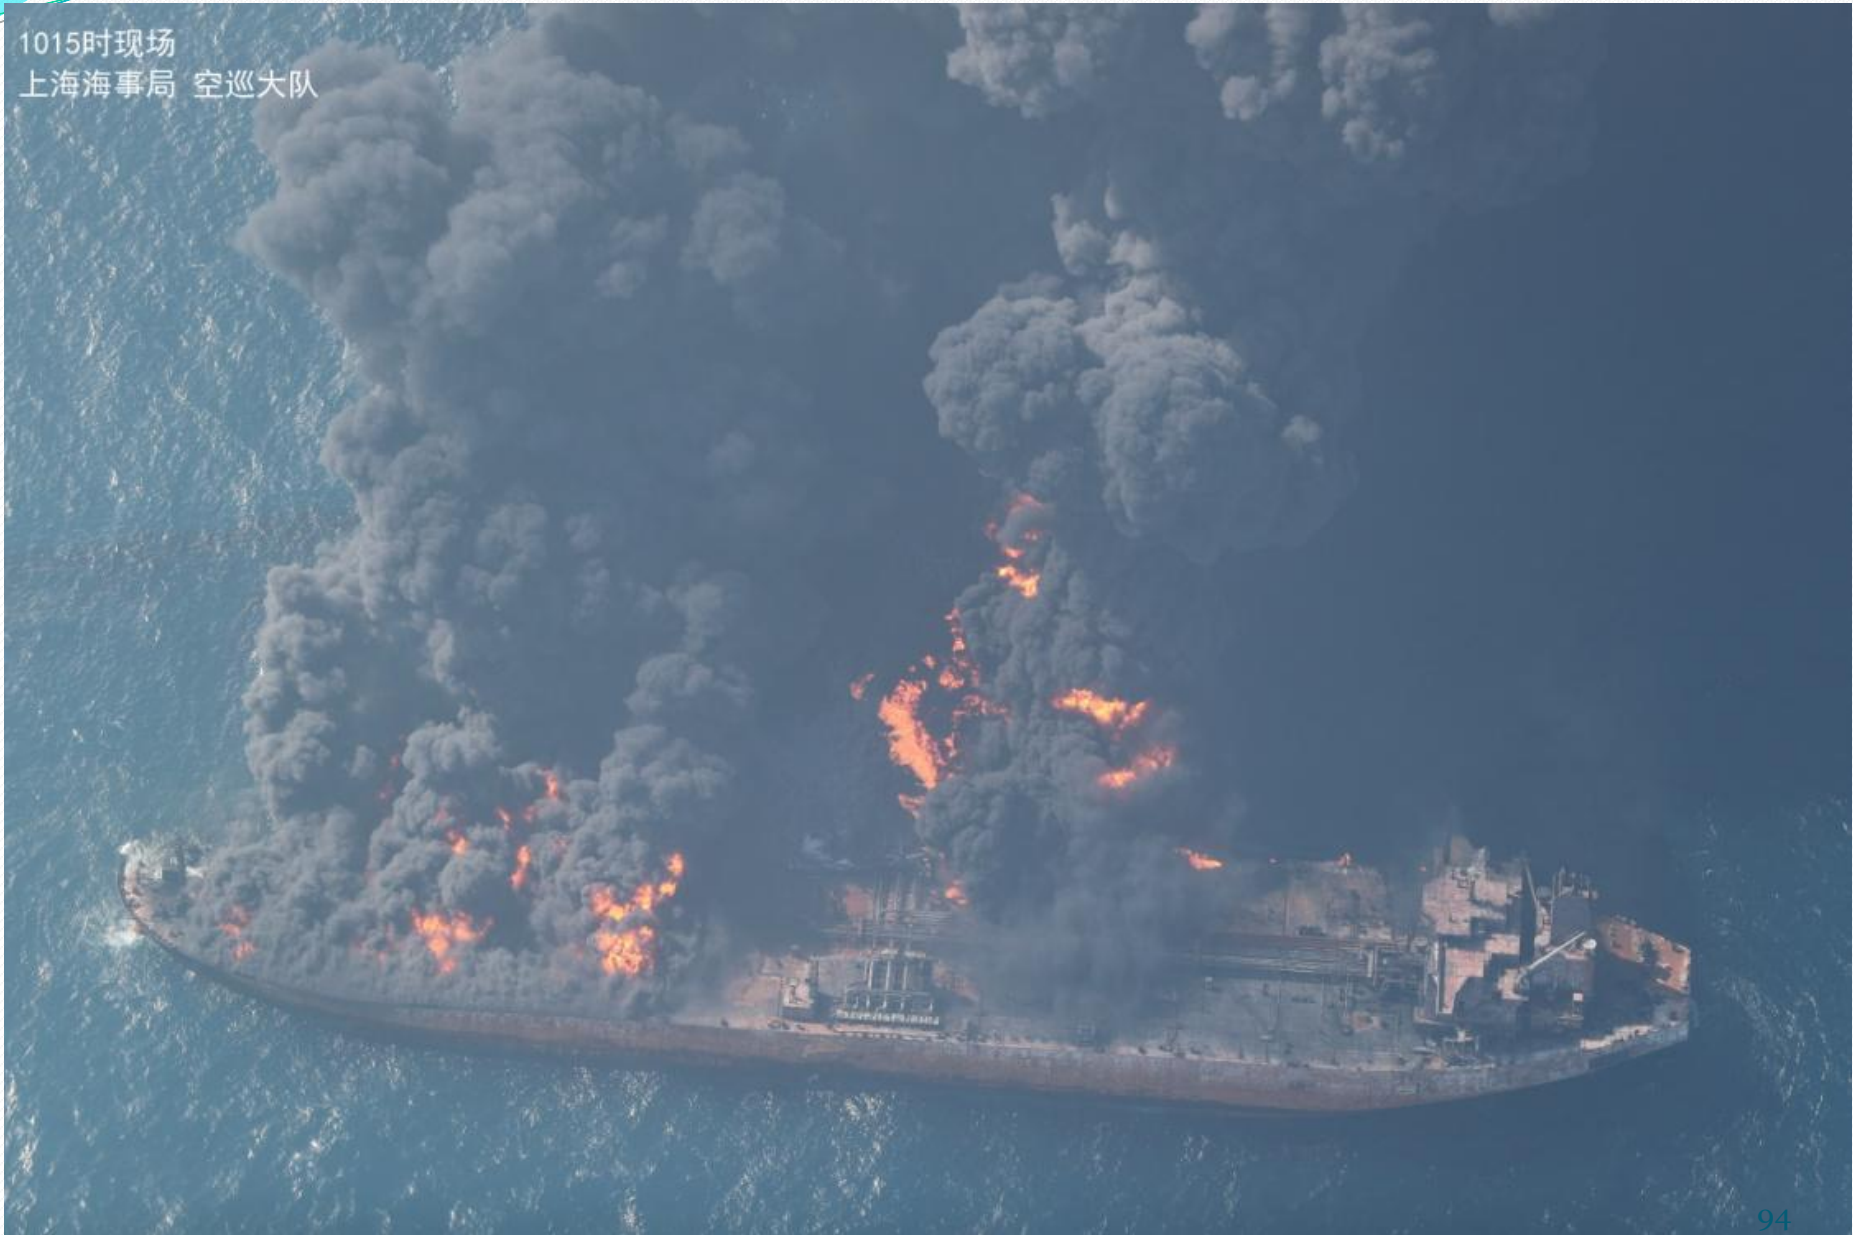
عکس هوایی از حریق تانکر سانچی

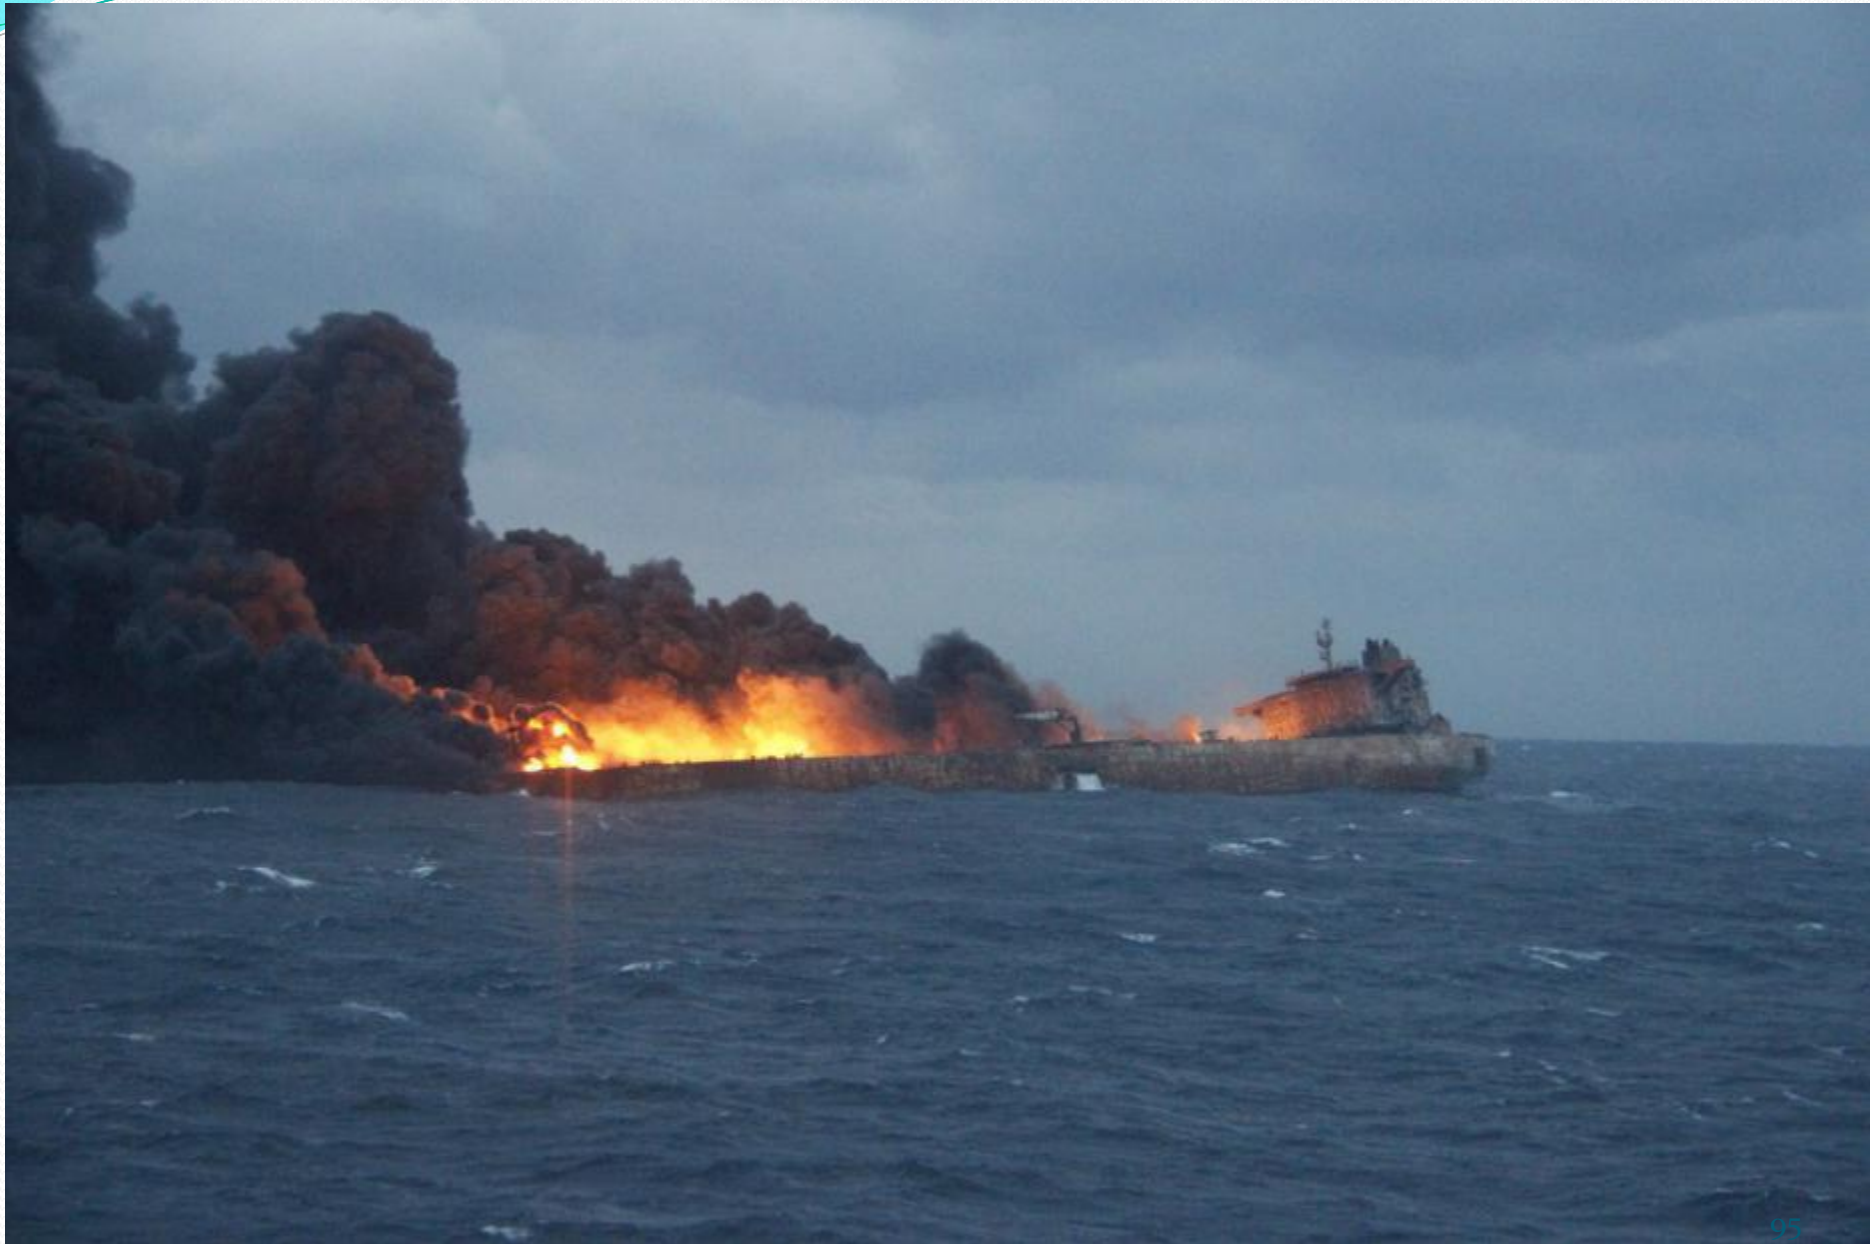
سرایت آتش به تمامی انبارها و توسعه حریق سانچی
